AN ENGINEERING VIEW OF THE FIRE OF MAY 4, 1988 IN THE FIRST INTERSTATE BANK BUILDING LOS ANGELES, CALIFORNIA

Harold E. Nelson

March 1989

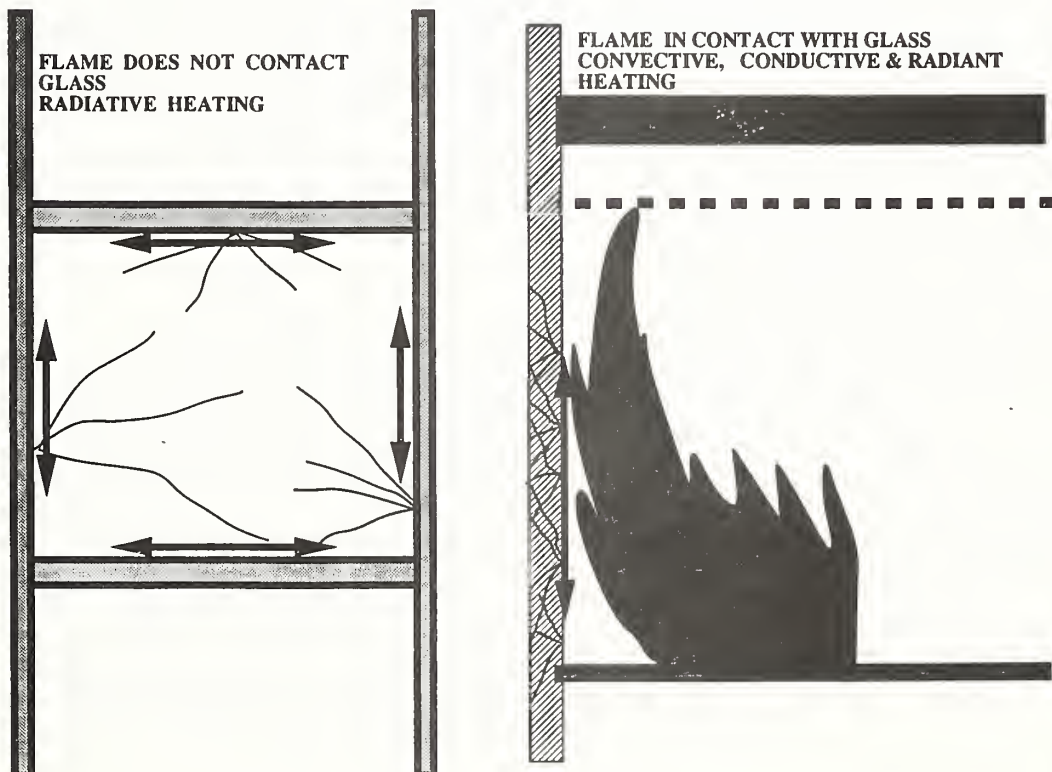
FIGURE 19. FIRE CAUSES OF GLASS BREAKAGE

One reason that it is not possible to determine whether the windows broke before or after flashover is that glass characteristically breaks in two manners.

- a. Radiant heating without flame contact. If flame does not contact the glass surface, heating of the glass is by radiant energy. In that case, the portions of the glass shielded from direct radiation do not heat-up as quickly as that portion exposed to direct radiation. As this occurs, internal stresses build up in the glass due to the greater thermal expansion of the more heated surface over the shielded surface. Theoretical calculations have indicated that when the temperature difference between the shielded and unshielded portions of the glass reaches about 100 F, radial cracks will travel from the boundaries quickly reaching a point of failure of the glass.

- b. Flame in contact with glass. Where direct contact is made between flame and glass, a thermal shock causing massive stresses between the hot side and the cool side of the plate occurs. This causes rapid cracking through the glass and failure of the glass whether or not general heating of the glass has taken place. The thicker the glass, the more likely this type of failure.

On this basis, if the fire source location is near the core, flames probably did not reach the glass prior to the development of flashover temperatures. Flashover conditions then produced radiation that heated the glass to its point of failure. Conversely, if the point of initiation was close to the windows, flame contacted the glass and the windows broke prior to flashover. In this latter case the early venting of the fire may have prevented the development of true flashover conditions.

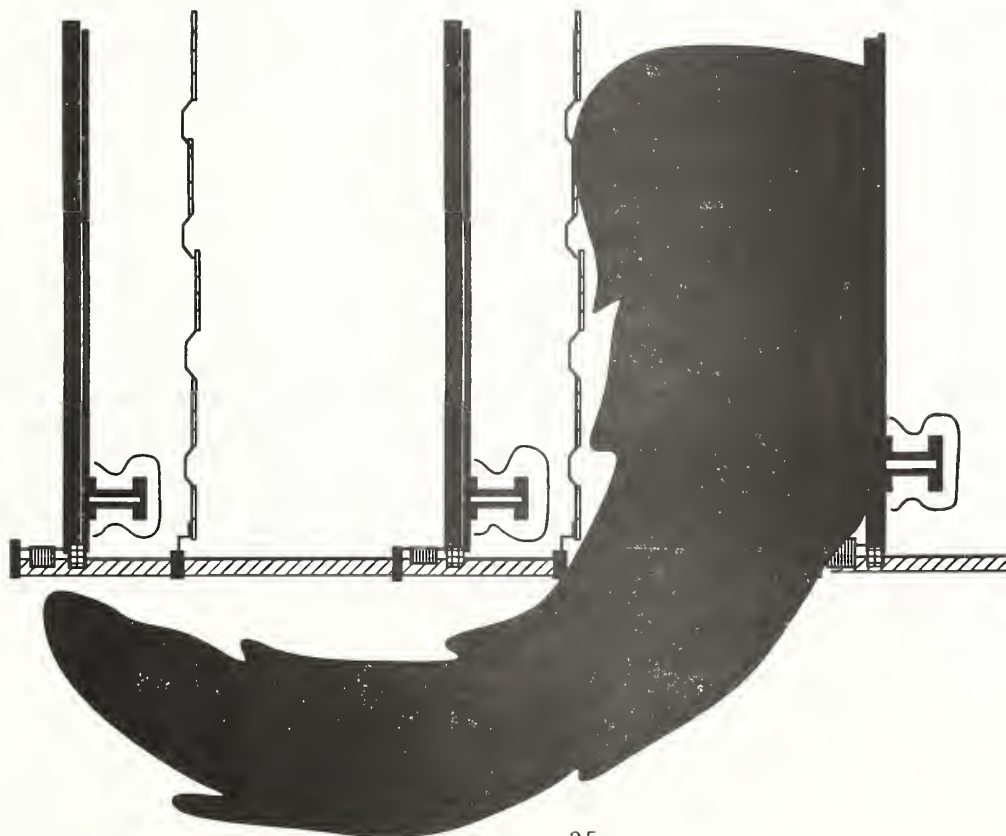
FIGURE 23. EXTENSION OF FUEL RICH FLAME

At the time of first breakage, it was likely that the fire is on the fuel rich side and expelled significant quantities of unburned gases forming a large flame, such as shown in figure 23. Such a flame could have broken glass and started some ignitions on the floor above or, failing to break the glass, radiated the material on the 13th floor preheating it. Since no ignitions are reported on the 13th floor at this time, the latter condition is more likely.

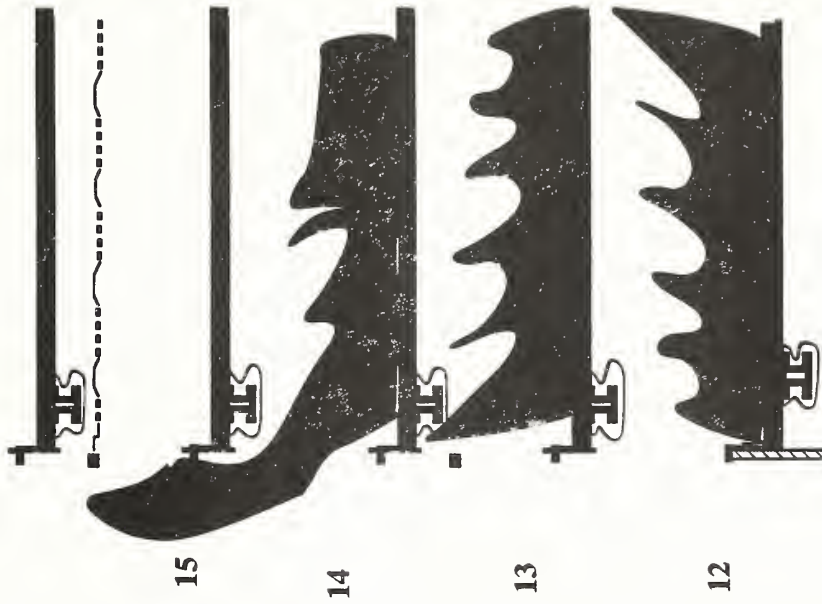
FIGURE 28. FIRE EXTENSION TO THE
15TH FLOOR

The reported time of extension to the 15th floor is about 12:20 a.m. Figure 28 depicts the envisioned relationship of flame orientations. This emphasizes the concept that flame being drawn in on the lowest floor and pushed out on the highest floor with the upward movement of the neutral plane.

ABOUT 12:20 AM IGNITION ESTABLISHED ON
15TH FLOOR

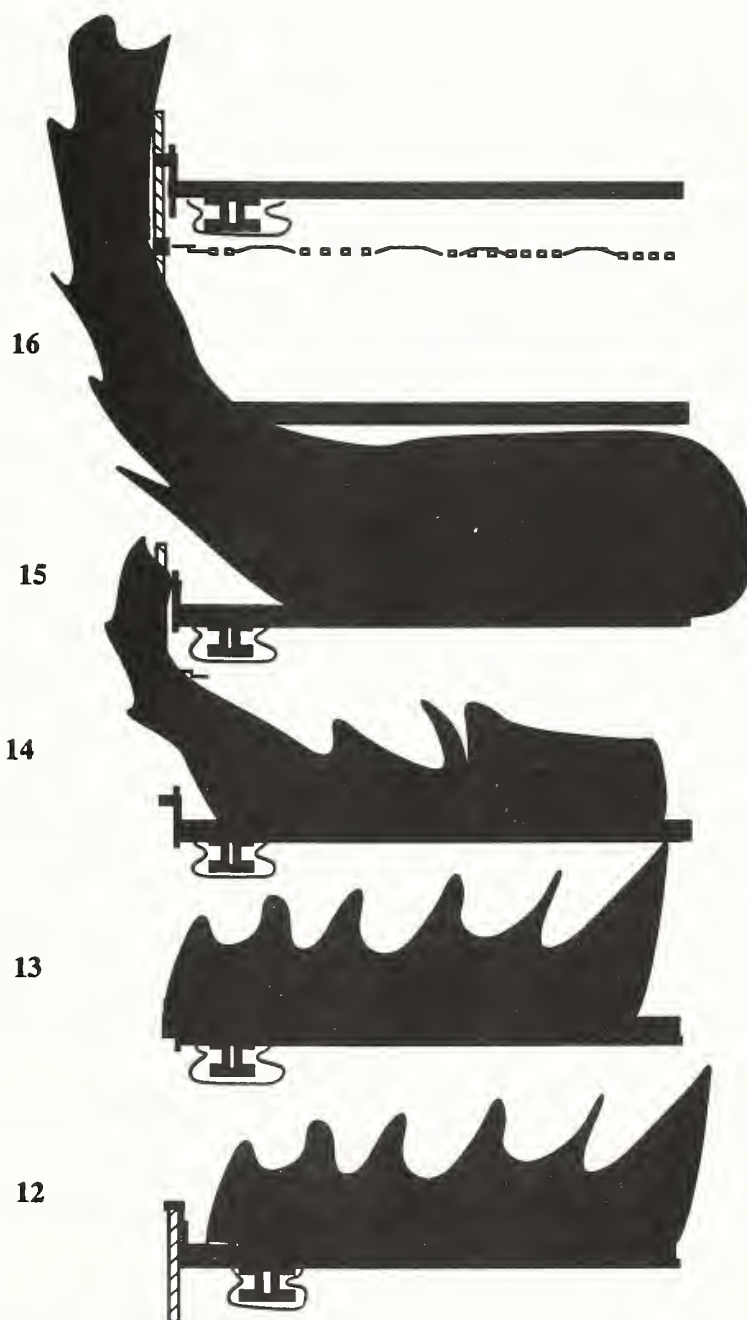
FIGURE 29. FIRE EXTENTION TO THE 16TH FLOOR

Figure 29 shows a very tall flame extension from the 15th to 16th floor. The fire department now stops the fire on the 16th floor. Direct fire damage is limited to the north end and the south west corner of the floor. The 16th floor is the only floor where a fire stop is made soon enough to preserve evidence of the means of fire propagation. The burned ceiling portion over unburned furniture in the south west section of this floor is evidence of exterior flame penetration lapping from the 15th floor onto the 16th floor ceiling. An extensive flame is necessary to produce this result.

ABOUT 12:50 AM IGNITION ESTABLISHED ON 16TH FLOOR
